# CORNER RECORD

COUNTY OF Monro T. 1N R. 27E  MDB E MERIDIAN CALIFORNIA

CORNER IDENTIFICATION - DATE OF VISIT Sept 2 19 77

DOCUMENT No. 111 27-20-1

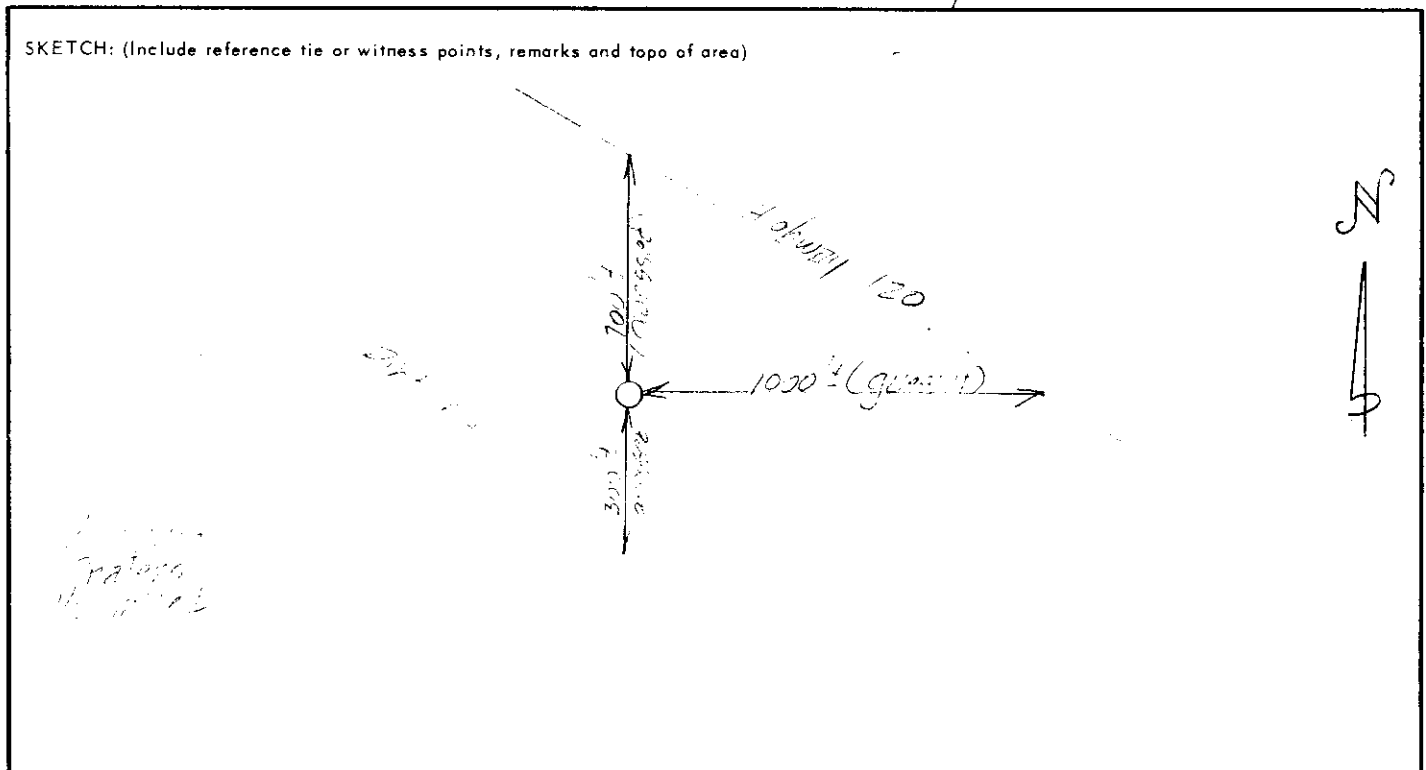
SKETCH: (Include reference tie or witness points, remarks and topo of area)

PHYSICAL DESCRIPTION OF CORNER FOUND: EVIDENCE AND METHOD USED TO IDENTIFY OR REESTABLISH Fe 1000  
pipe, 40 0.2, in loose round of 12 1/2" with 1 1/2" x 6" = pipe  
12 1/2" x 27 side. Fe 1000 - wood plug with tack and tag 10467  
in it

Fe 1000 - Fe 1000 - North at Mon; Fe 1000 - NE at Mon;  
Fe 1000 - Fe 1000 - WSW at Mon
