**CAMBODIA NORTHWEST PROVINCIAL ROAD
IMPROVEMENT PROJECT
EDCF LOAN NO. KHM-9**

Contract Name: Improvement of National Road No. 56 from km 29 to Samraong

GEOTECHNICAL INVESTIGATION

MATERIALS REPORT

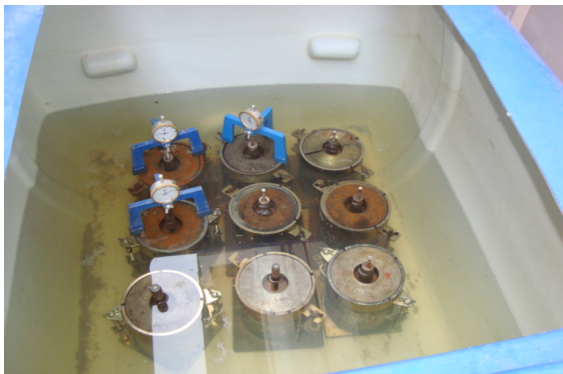
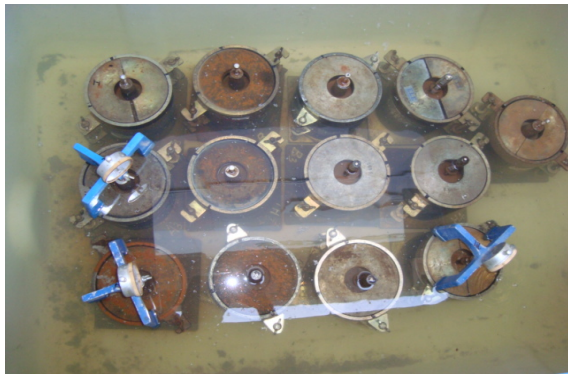
Sample soaking at laboratory

The sub-grade, sub-base, base strength and other engineering characteristics were determined using the California Bearing Ratio (CBR) tests. The three points CBR method was adopted, where the specimens were soaked for 96 hours. The method allows interpolating the CBR values at various dry densities of soil. Three points obtained from CBR test represented the different compaction energies at 10, 30 and 65 blows using 4.54 Kg hammer dropped at a height of 0.457m for five layers of soil in the compaction cylinder mould.
